Behaviour of a concrete structure in a real compartment fire

In July 2006, a full-scale compartment fire was set in an existing block of flats in Dalmarnock, Glasgow, Scotland. Prior to ignition, the structure was instrumented with deflection gauges, thermocouples and strain gauges. The growth of the fire was also carefully monitored. The resulting data provided a unique record of the behaviour of a concrete structure in fire through a heating–cooling cycle. The results show significant variation in structural temperatures within a relatively small compartment, demonstrating that the assumption of uniform temperature at any level within a fire compartment, which is implicit in many simple design fires, is incorrect. The response of the structure showed a corresponding complexity due to the combination of non-uniform spatial and temporal heating and the structural boundary conditions.

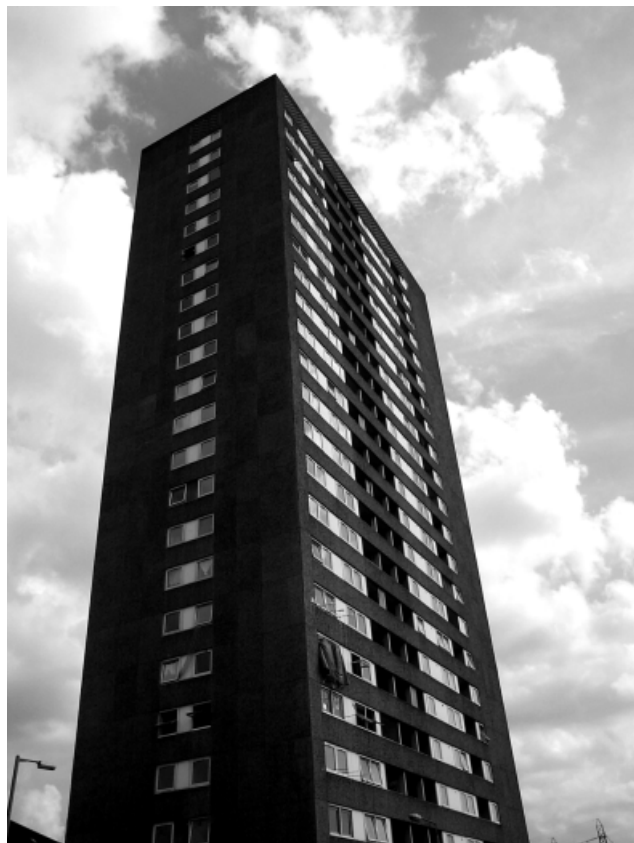
Figure 1. 4 Millerfield Place, Dalmarnock, the location of the fire test

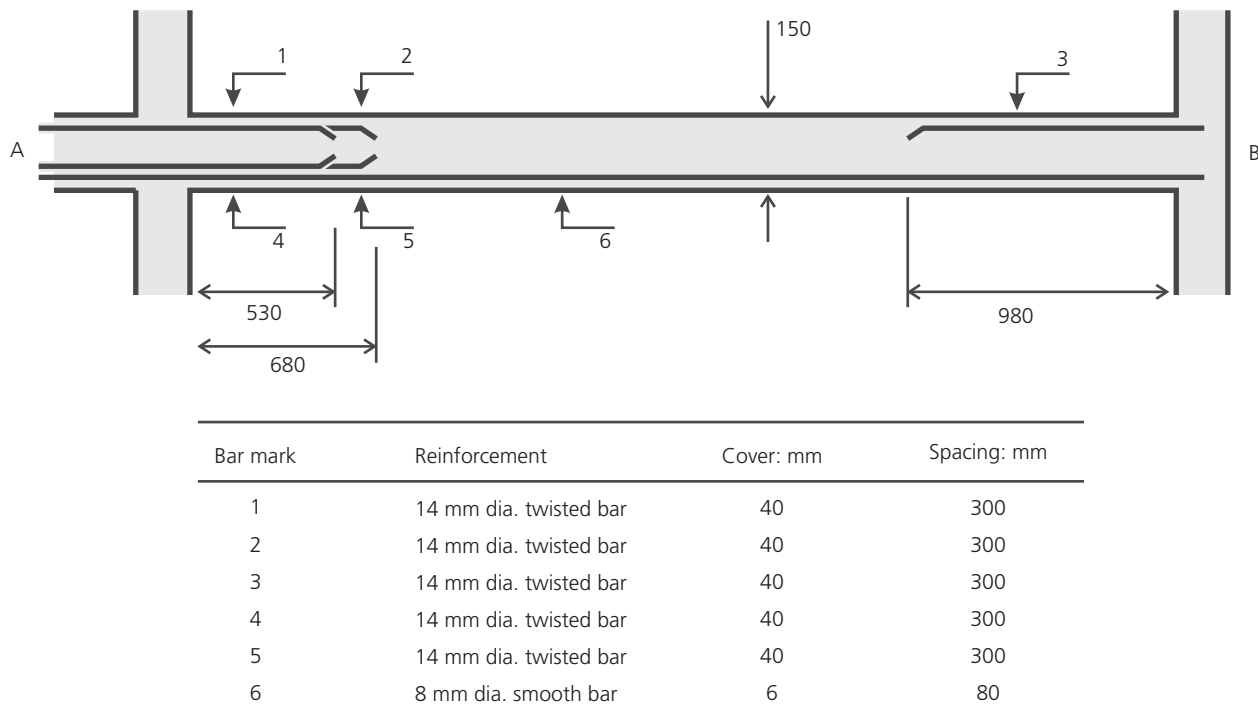
Figure 4. Section through the ceiling slab showing the reinforcement layout (the location of the section is marked A–B on Figure 3) (dimensions in mm)

There was no evidence of any hot gases entering the room above the fire compartment. The upper surface of the slab contained visible cracks at the locations shown in Figure 9. These cracks generally coincided with the lines at which reinforcement in the upper part of the slab was curtailed (Figure 4). This is unsurprising, due to the step change in flexural capacity at these locations.

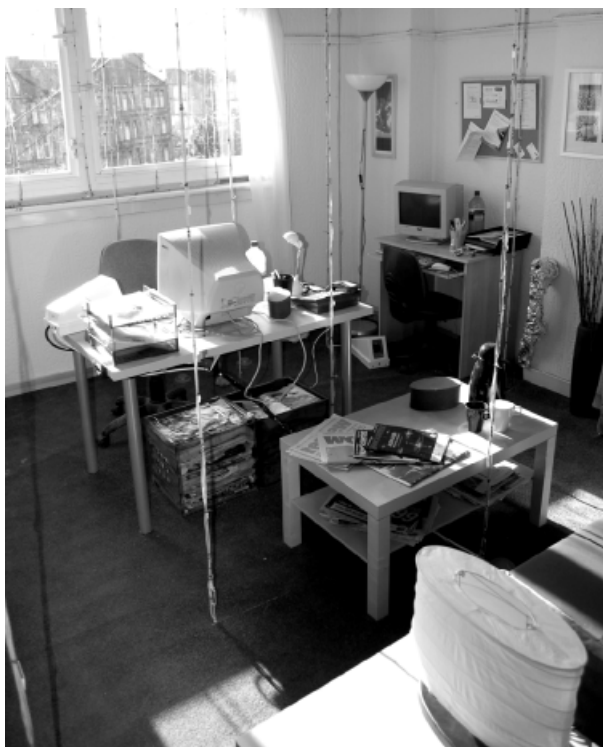
The fire load in the compartment consisted of office furnishing, with the main fire load coming from a sofa placed in the middle of the compartment. Other items of furniture included bookshelves filled with paper, a desk, carpet, a computer and a chair. Figure 5 gives an overview of the compartment furnishings, with the sofa partly visible in the bottom right-hand side of the photograph. The fire was started by the ignition of a waste paper basket next to the sofa. Further details of the fire load can be found in Rein *et al.* (2007).

Figure 5. Photograph of the fire compartment showing the fuel loading (looking north–west)

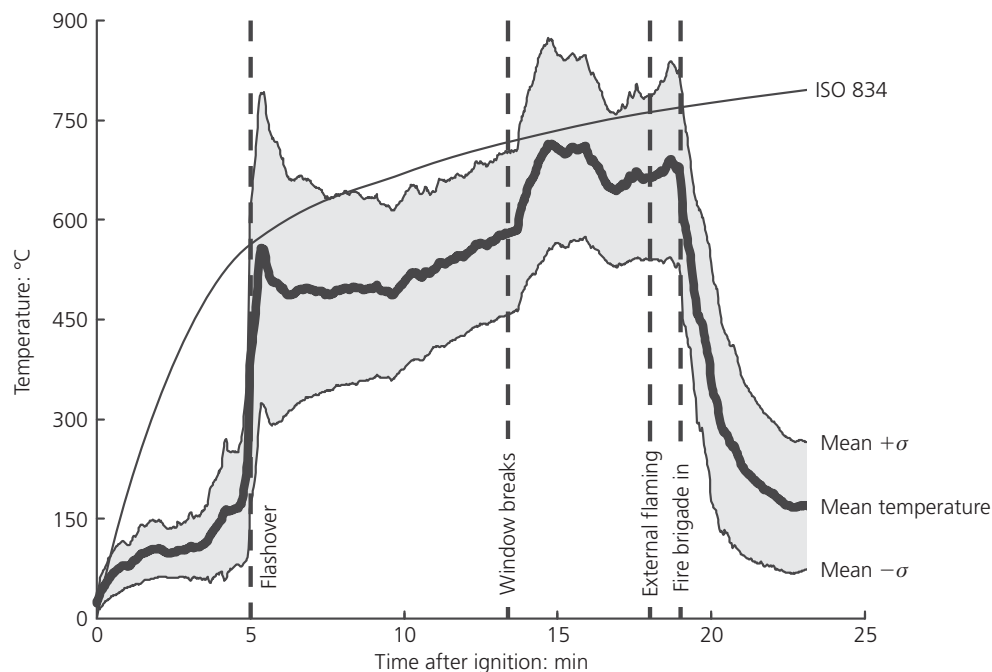
Figure 8 shows the evolution of gas phase temperatures measured within the fire compartment. It plots the mean temperature from 240 thermocouples distributed throughout the volume of the compartment, with the variation in temperature across the compartment indicated by the mean plus/minus one standard deviation curves. The ISO 834 time–temperature curve is included as a benchmark against which the experimental results can be compared. The three main phases of the fire are shown in Figure 8 (corresponding to the events listed in Table 1)

- (a) the growth period, ending with flashover 5 min after ignition
- (b) the fully developed fire, during which the ventilation regime changed at around 13 min when the window was broken, and external flaming beginning at 18 min
- (c) fire extinguished at 19 min by firefighters, after which temperatures decayed.

Figure 8. Gas phase temperatures recorded within the fire compartment (mean ± 1 standard deviation)

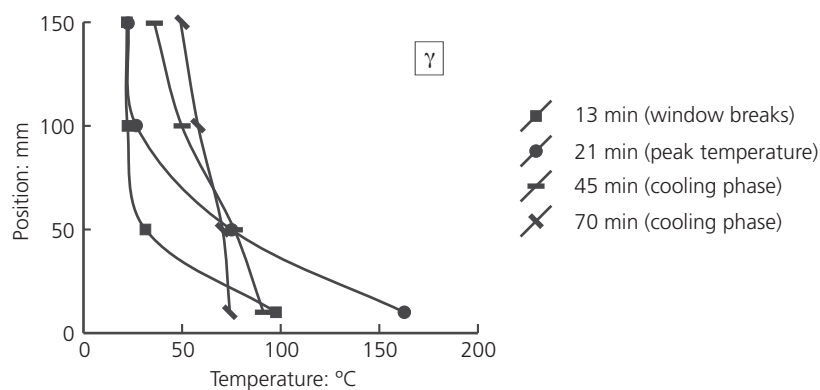
temperature of the lower surface of the slab dropped rapidly at all locations from around 20 min; this is because firefighters sprayed cold water onto the slab while extinguishing the fire. The internal portions of the slab maintained their temperatures despite fire-fighting activities; indeed, the upper layers of the slab continued to increase in temperature even after the fire was completely extinguished. For example, Figure 11 shows the temperature profile through the depth of the slab at location γ .

Figure 11. Temperature variation through the depth of the slab at location γ
